## 14.0 Rifle, Colorado, Disposal Site

### 14.1 Compliance Summary

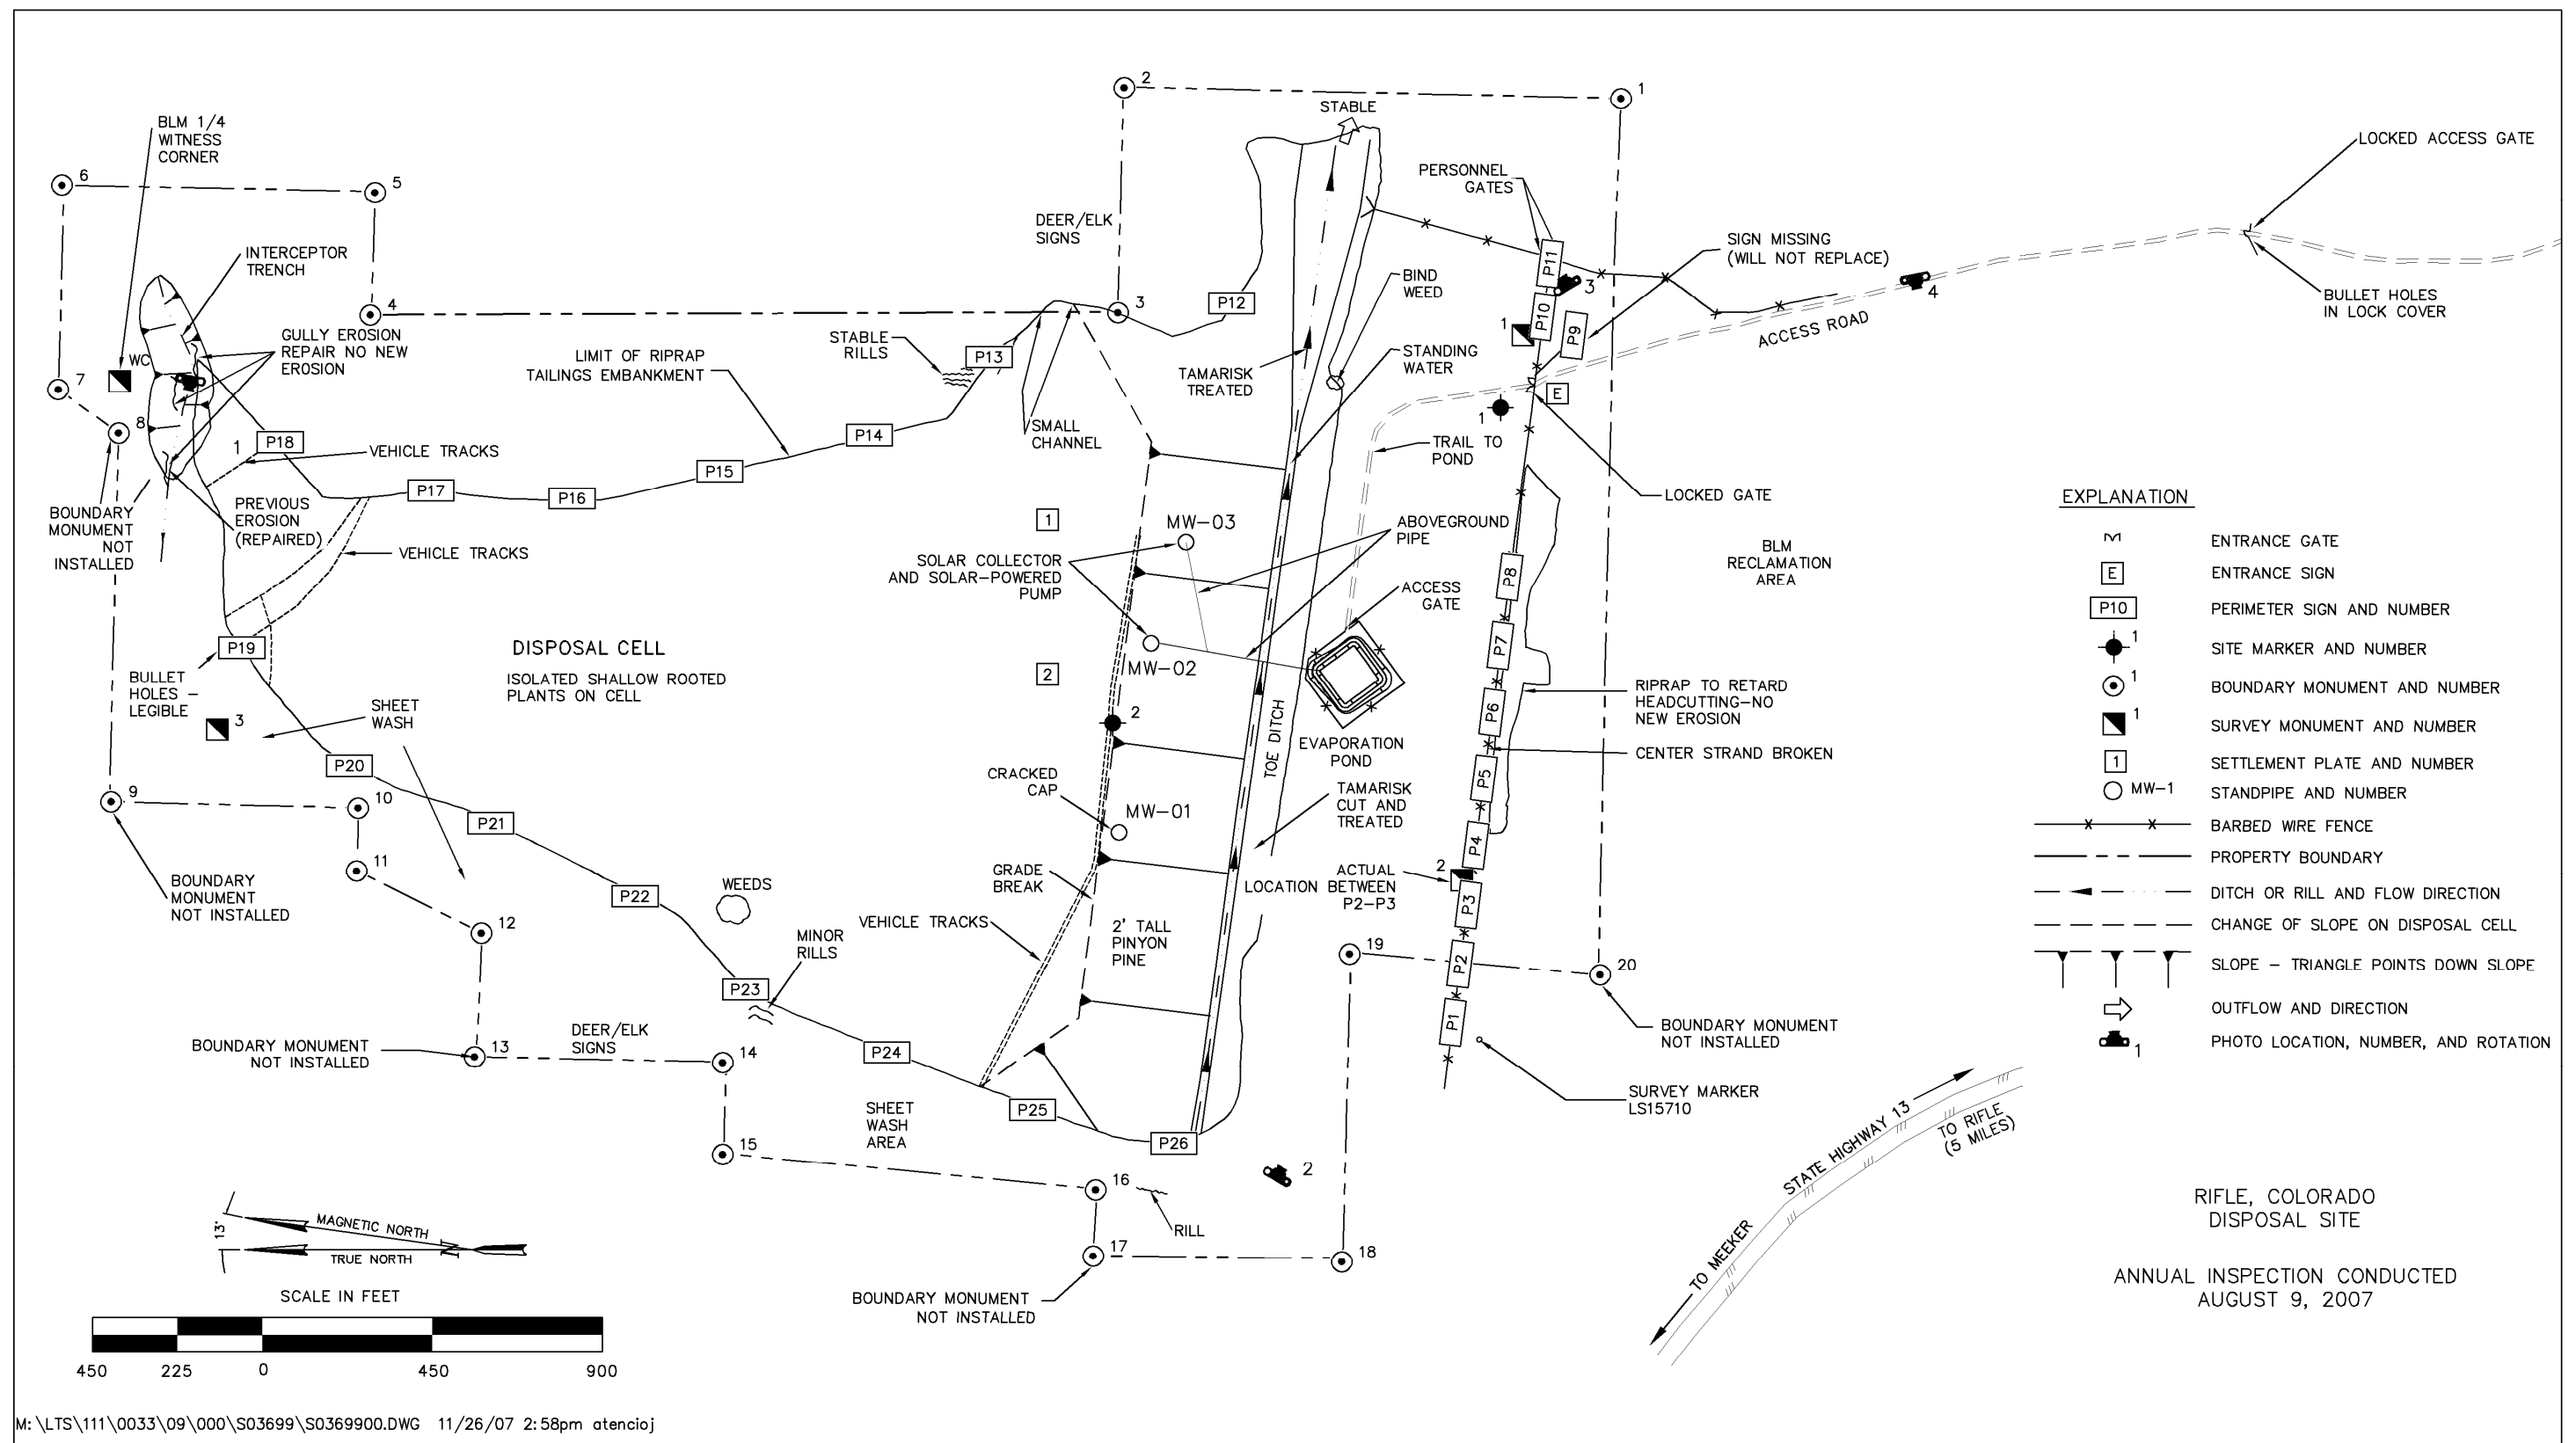
**Evaporation Pond**—An evaporation pond was constructed adjacent to the cell in 2001 to receive water pumped from standpipes MW–02 and MW–03. A datalogger, also with a remote data transfer system, measures water level fluctuations in the evaporation pond. The lined pond, surrounding security fence, and locked gate were in excellent condition.
